SANDVIK CHILE S.A
Inspección técnica
Di600
NUMERO DE SERIE 232

Date: september 30 - 2021

Type:	DTH
Model:	DI600
SN:	231
Engine Hs.	5921
Year:	2006
Site:	ICV Lo Aguirre
Description:	General Inspection

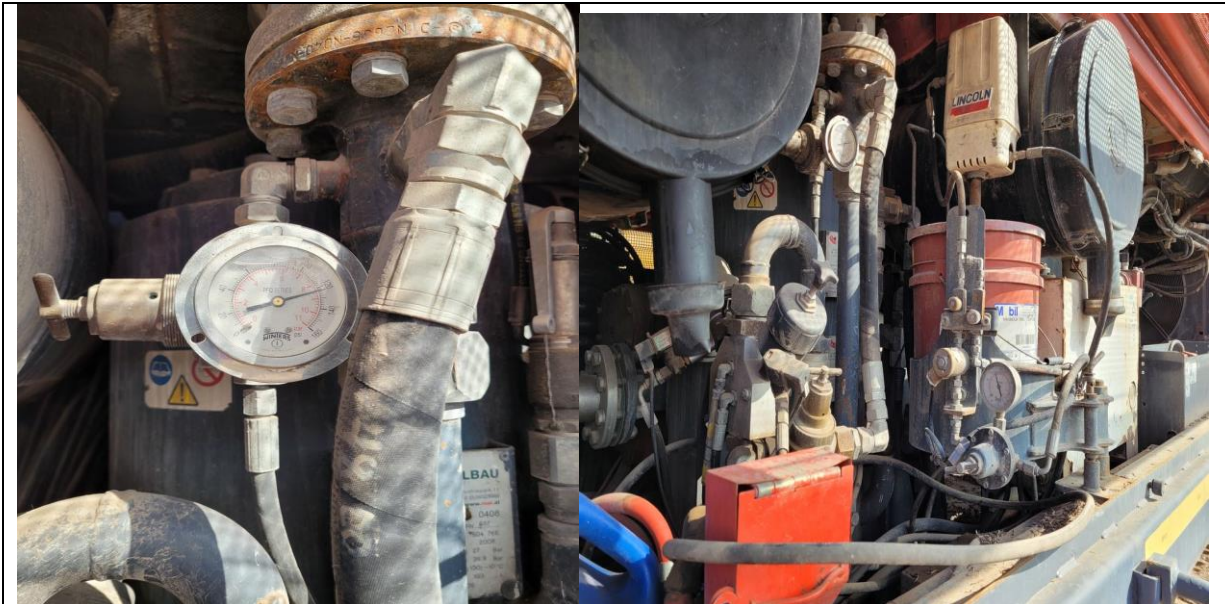
Compresor mínimo pressure 8,3 bar (120 psi), auxiliary pressure for complements 5,5 bar (80 psi)

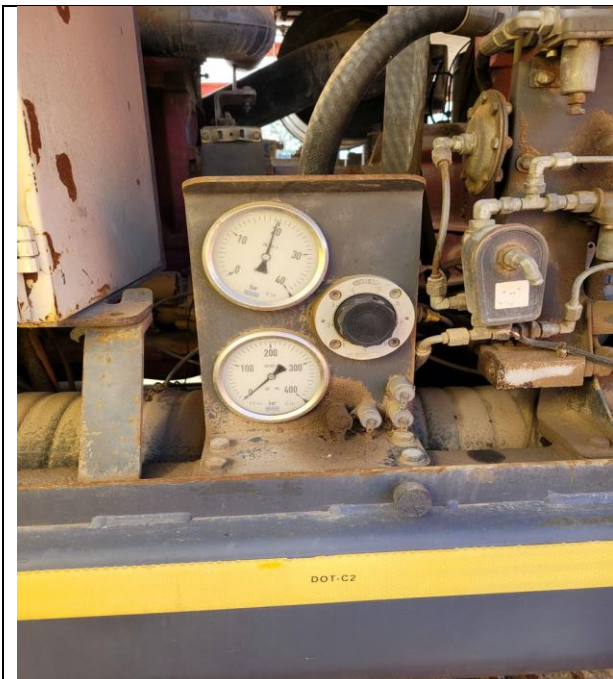
Stand-by pressure of Rotation pump 20 bar (290 psi)

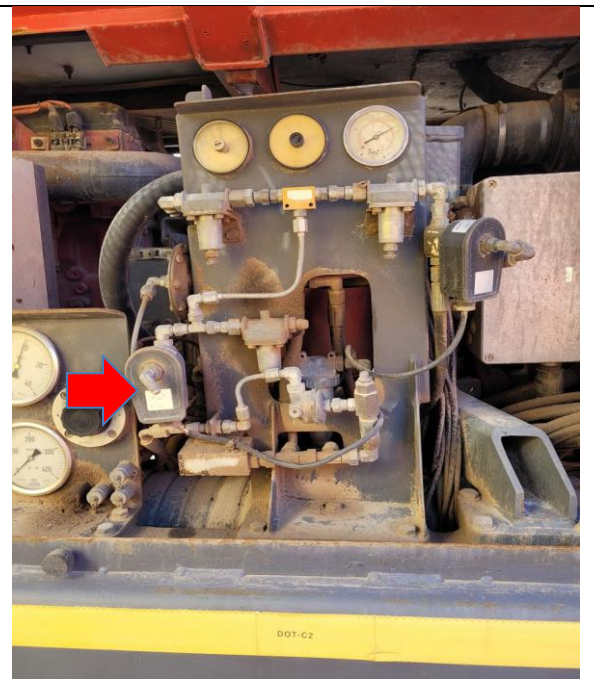
Drilling pressure control valve, pilot valve missing.

- Carry out total maintenance of the equipment, rust and lack of grease can be seen in general due to parking outdoors for a long time
- Order electrical lines of main board.
- Disassemble feed chain and sprockets for revision, maintenance and/or change.
- Replace missing pneumatic pilot lines

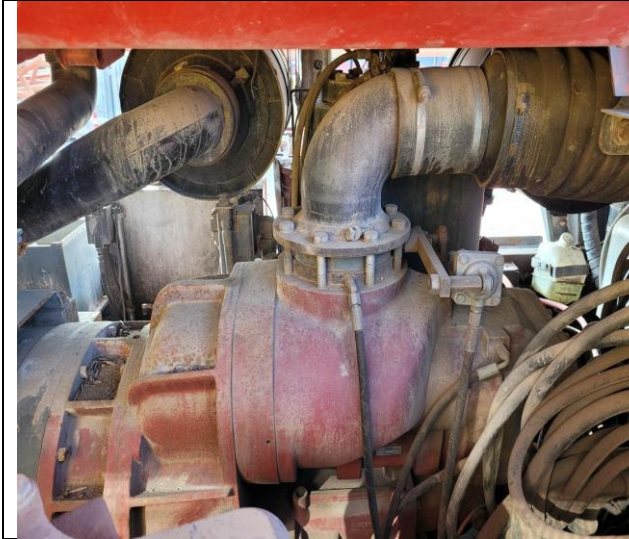
Compressor status normal and without leaks

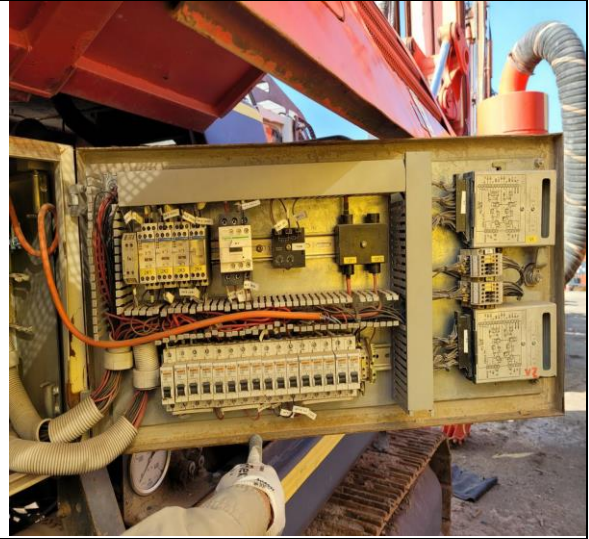
Main electrical box in good condition

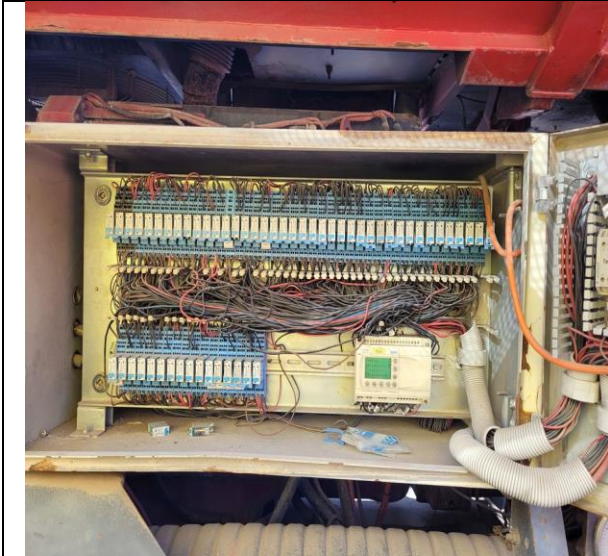
PLC working normally

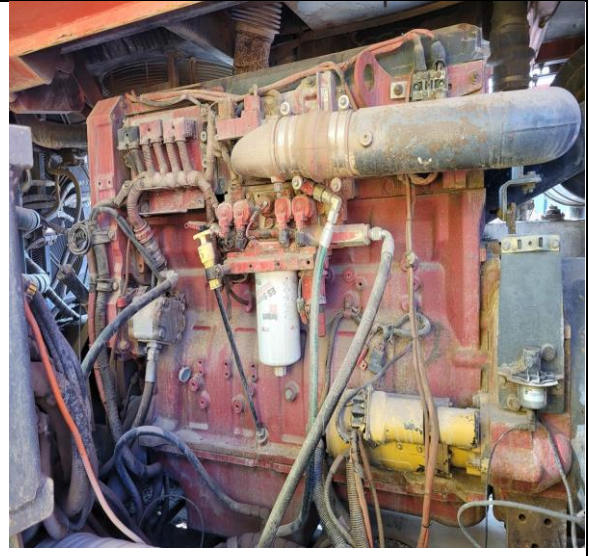
Diesel engine looks in good condition and has no leaks

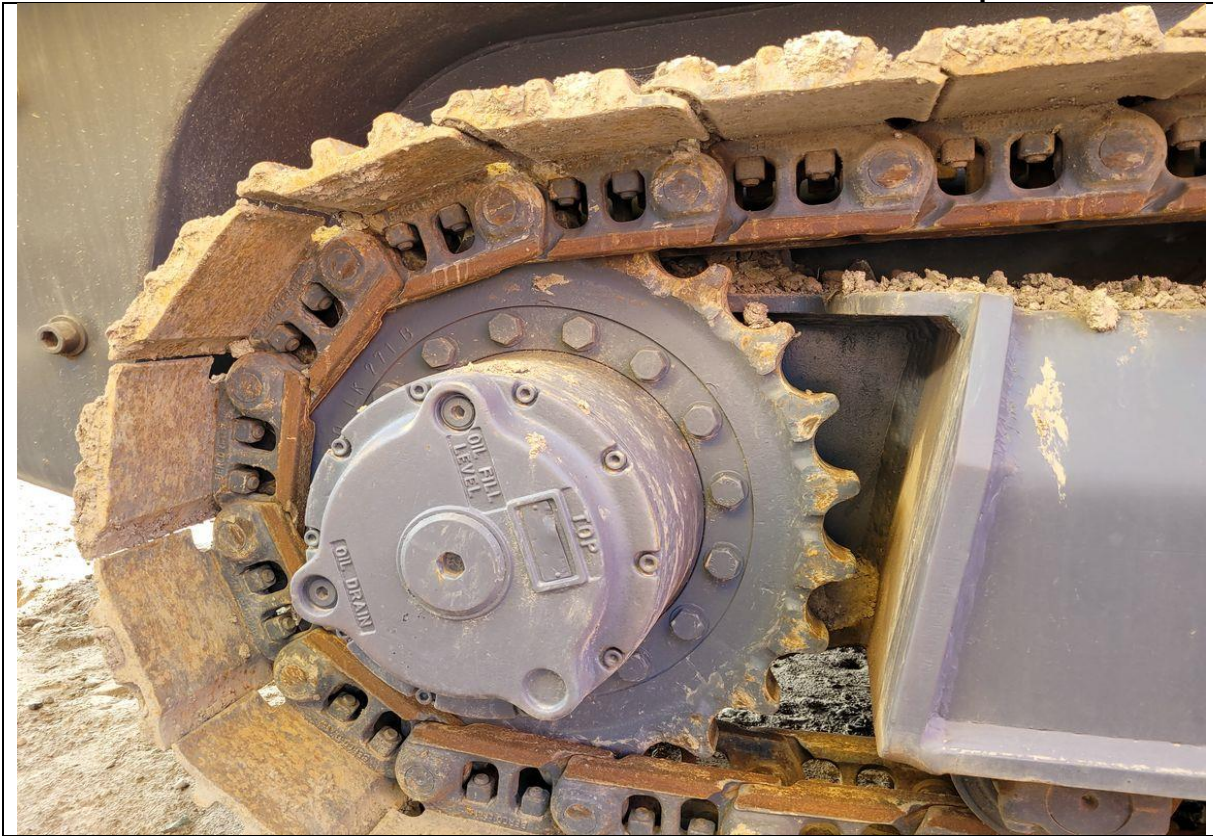
Final drives in good condition

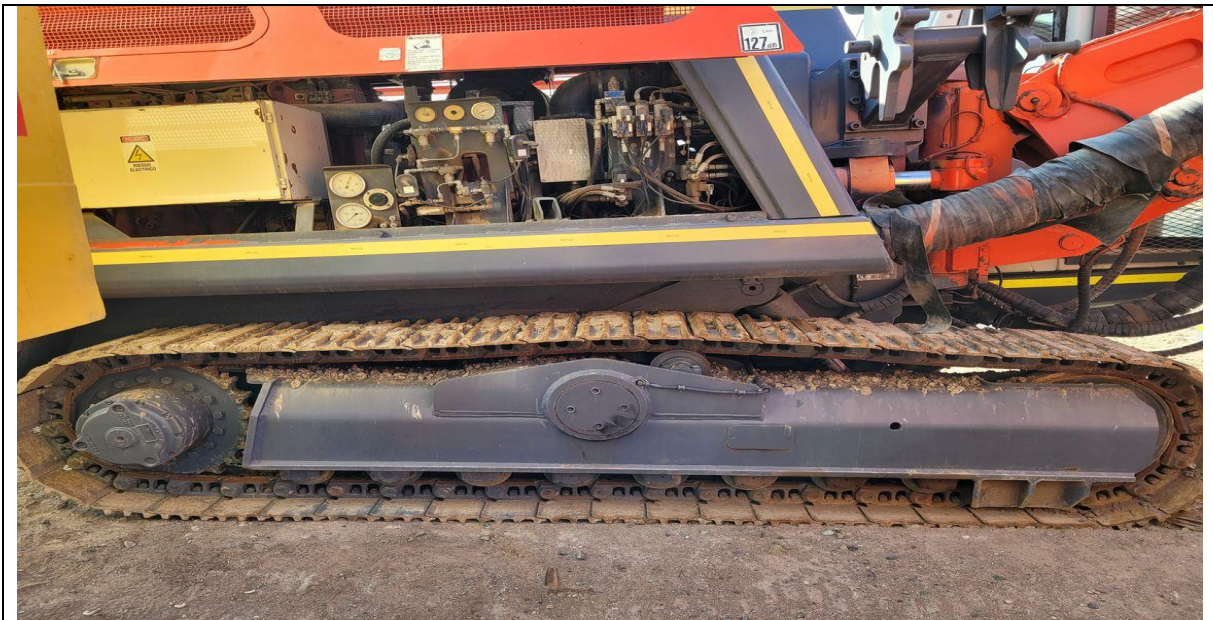
Frames in general are in good condition, they do not show cracks or abnormal wear.

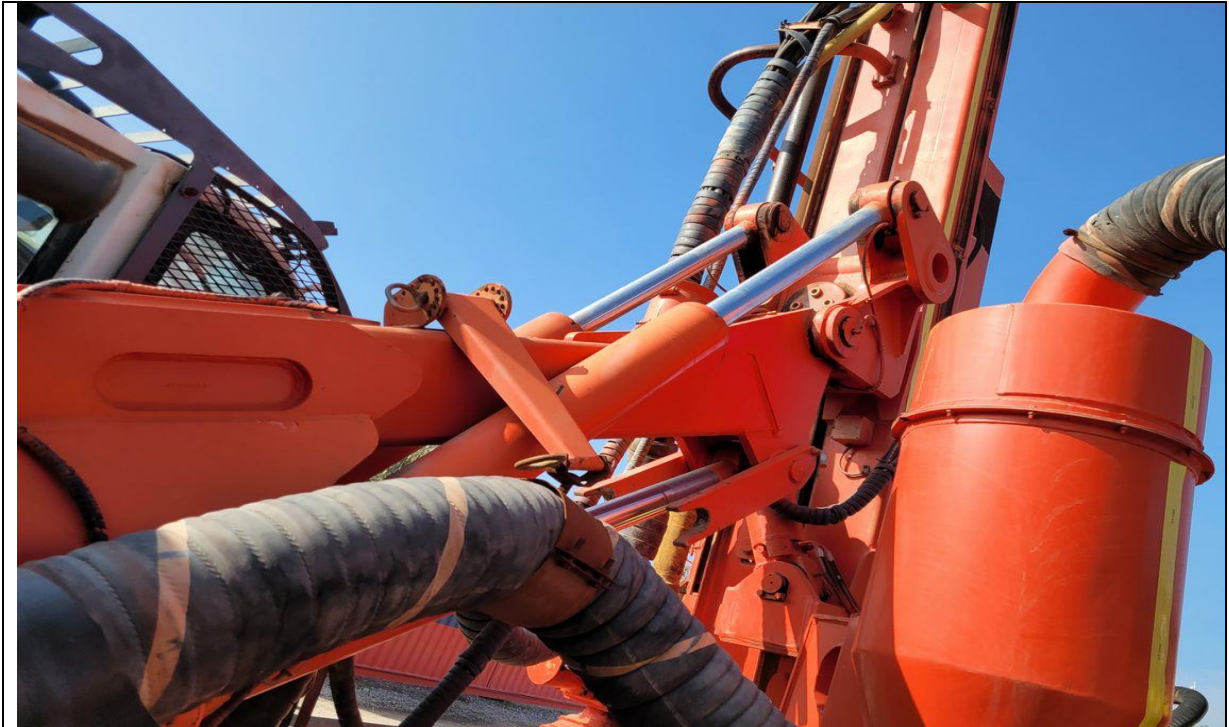
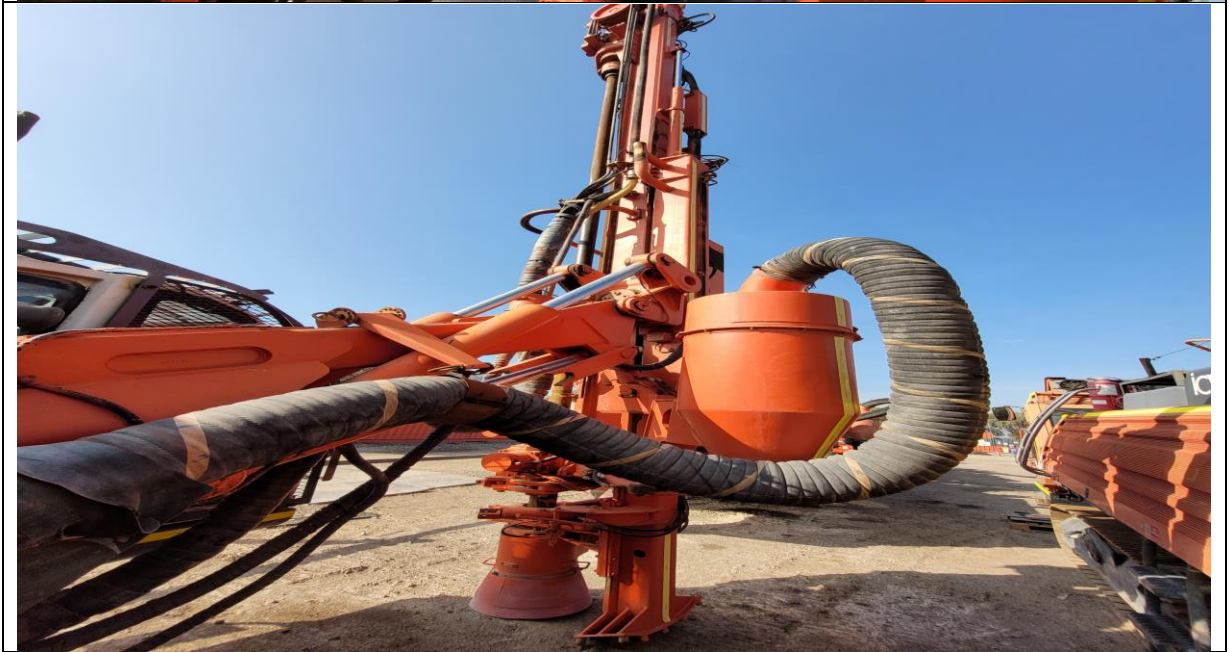
Hydraulic cylinders do not show oil leaks, chrome rods in good condition

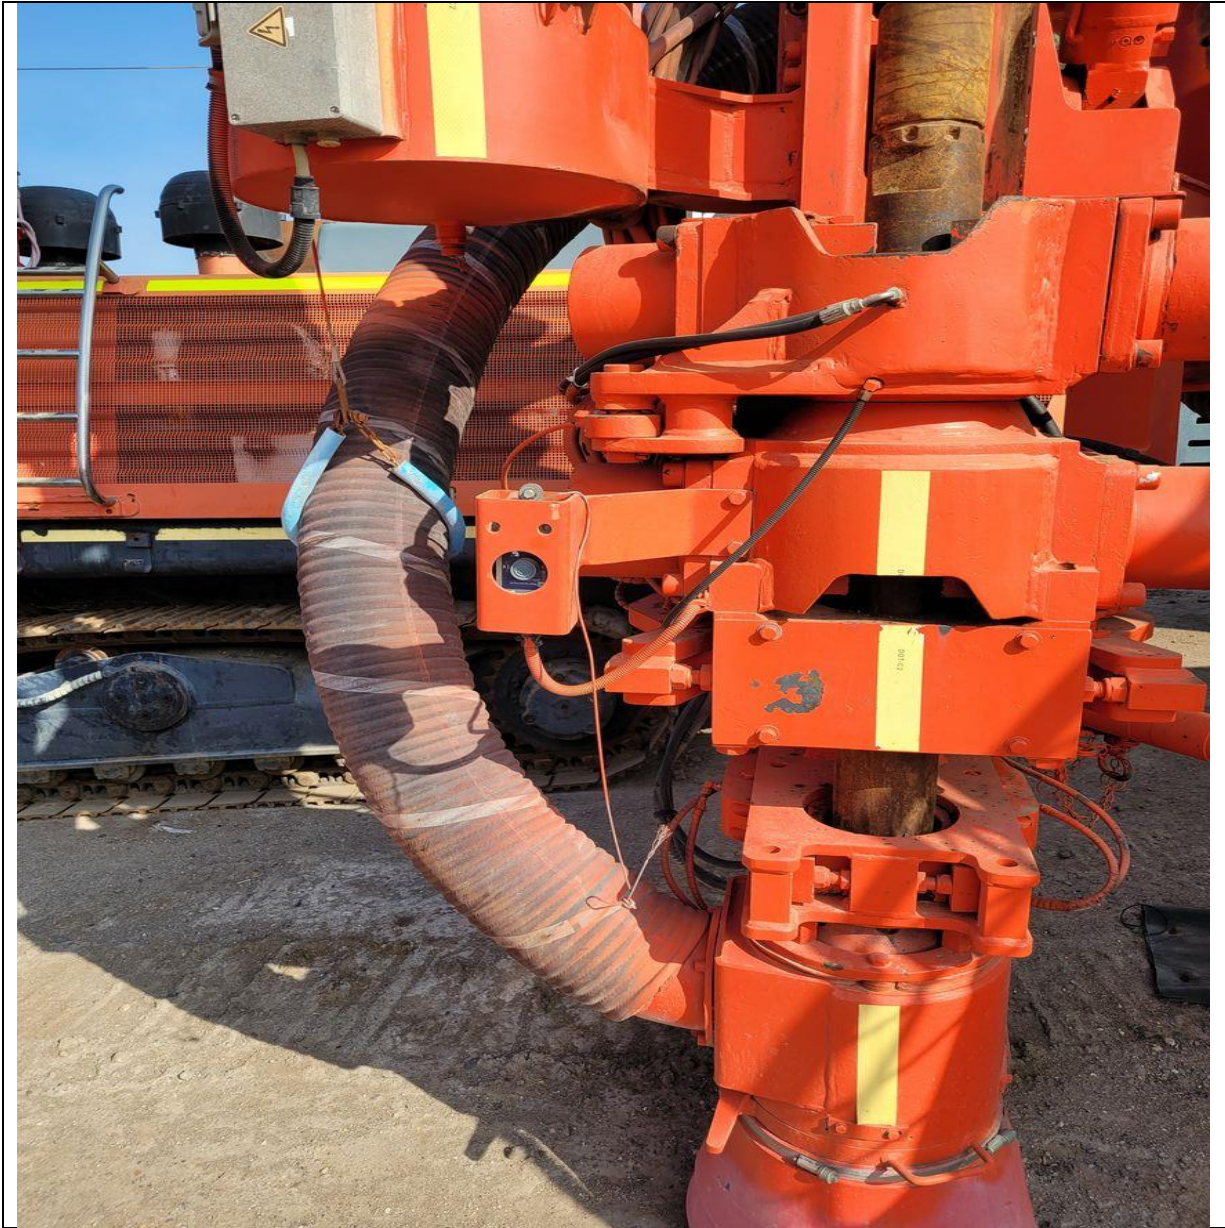
Break table and rod holder in good condition

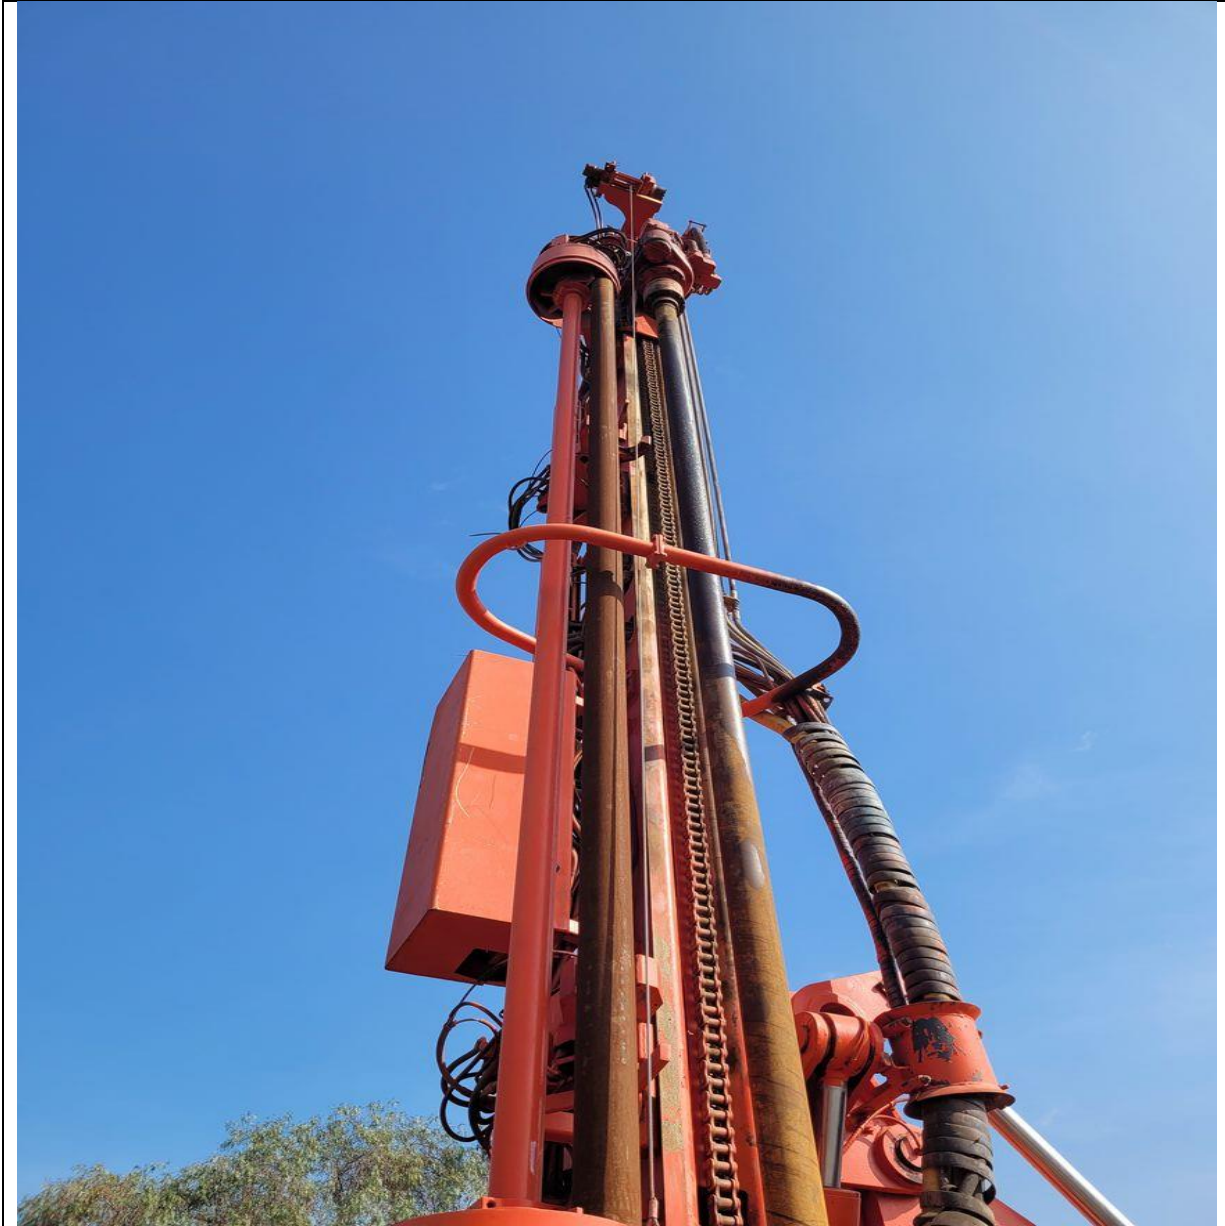
Rod handler in good condition, feed chain shows some rust

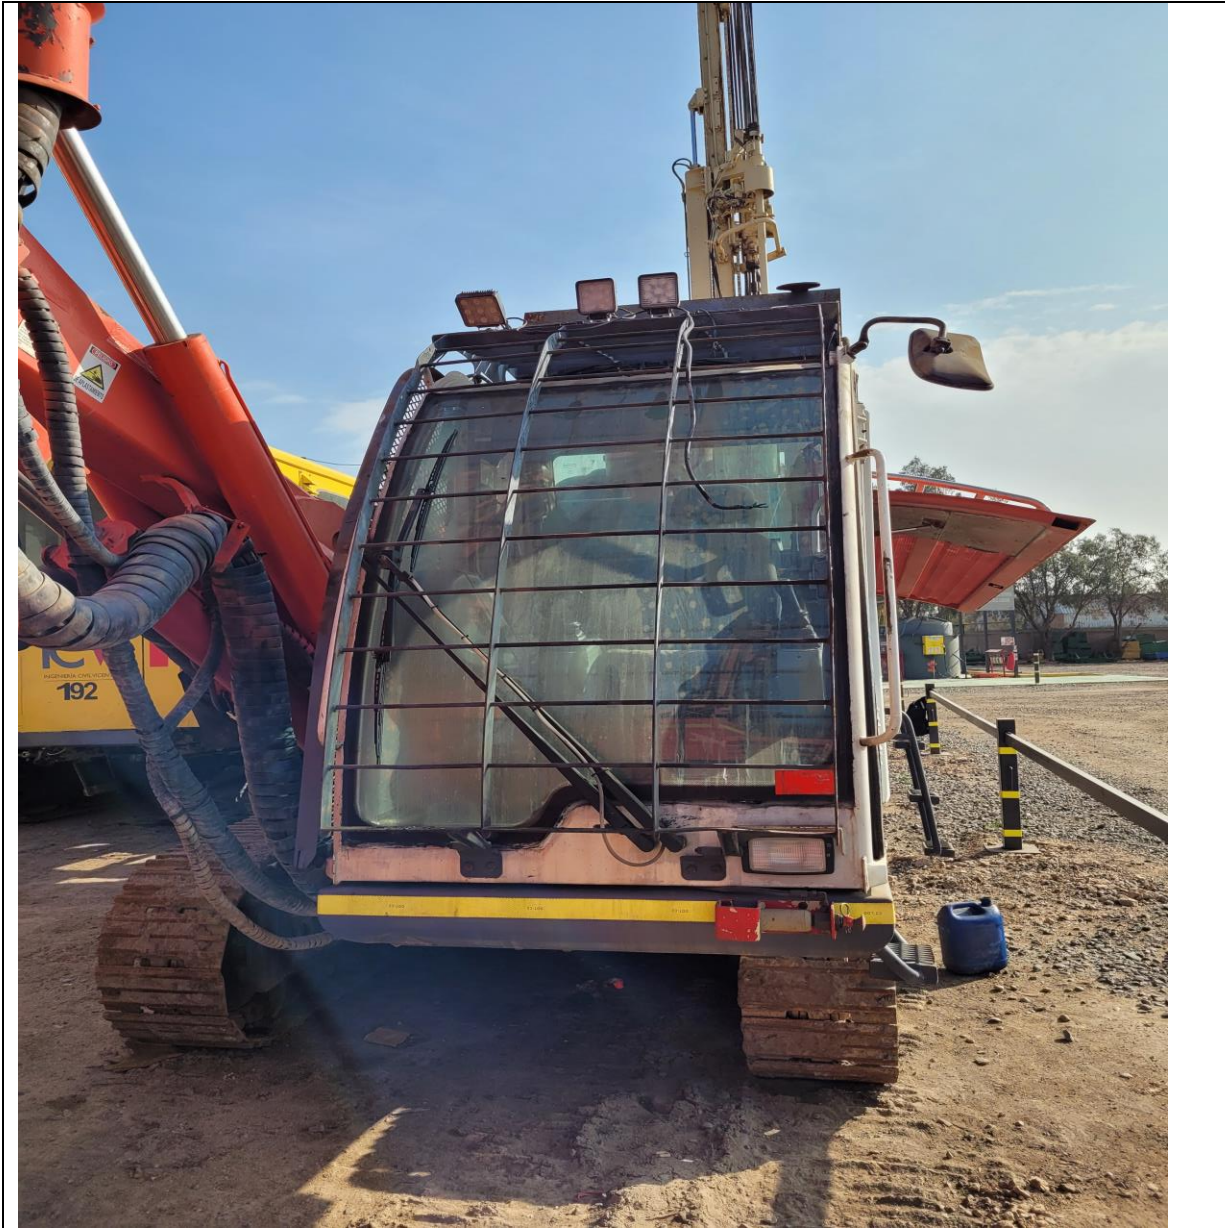
Cabin in good condition, no broken glass or bumps

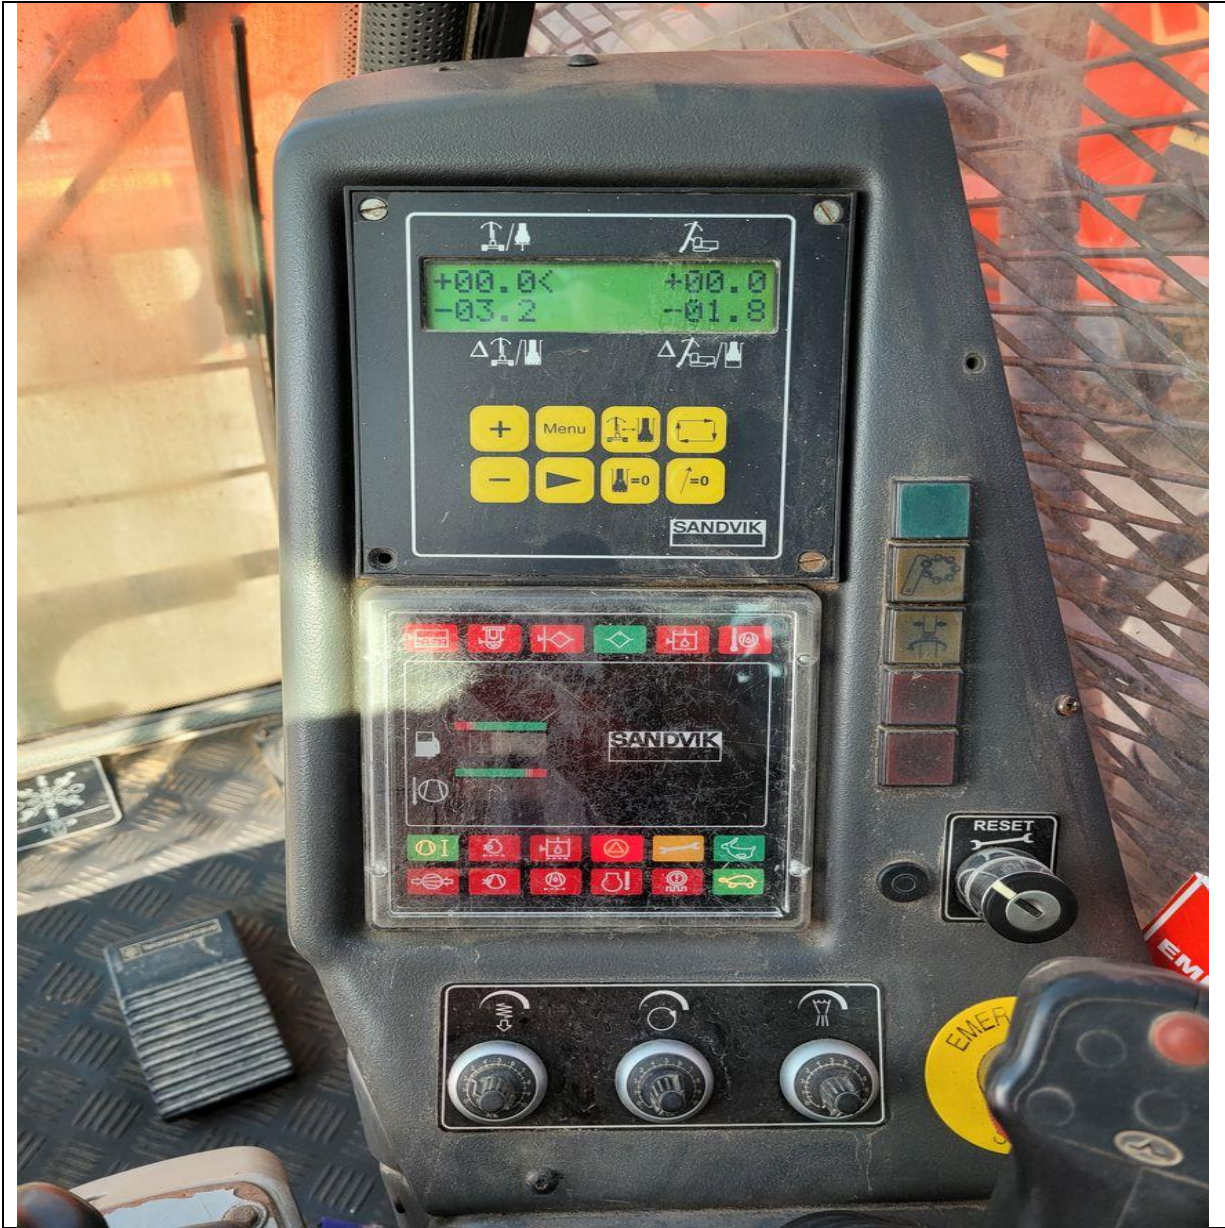
Control panel does not maintain active alarms, inclinometer working normally

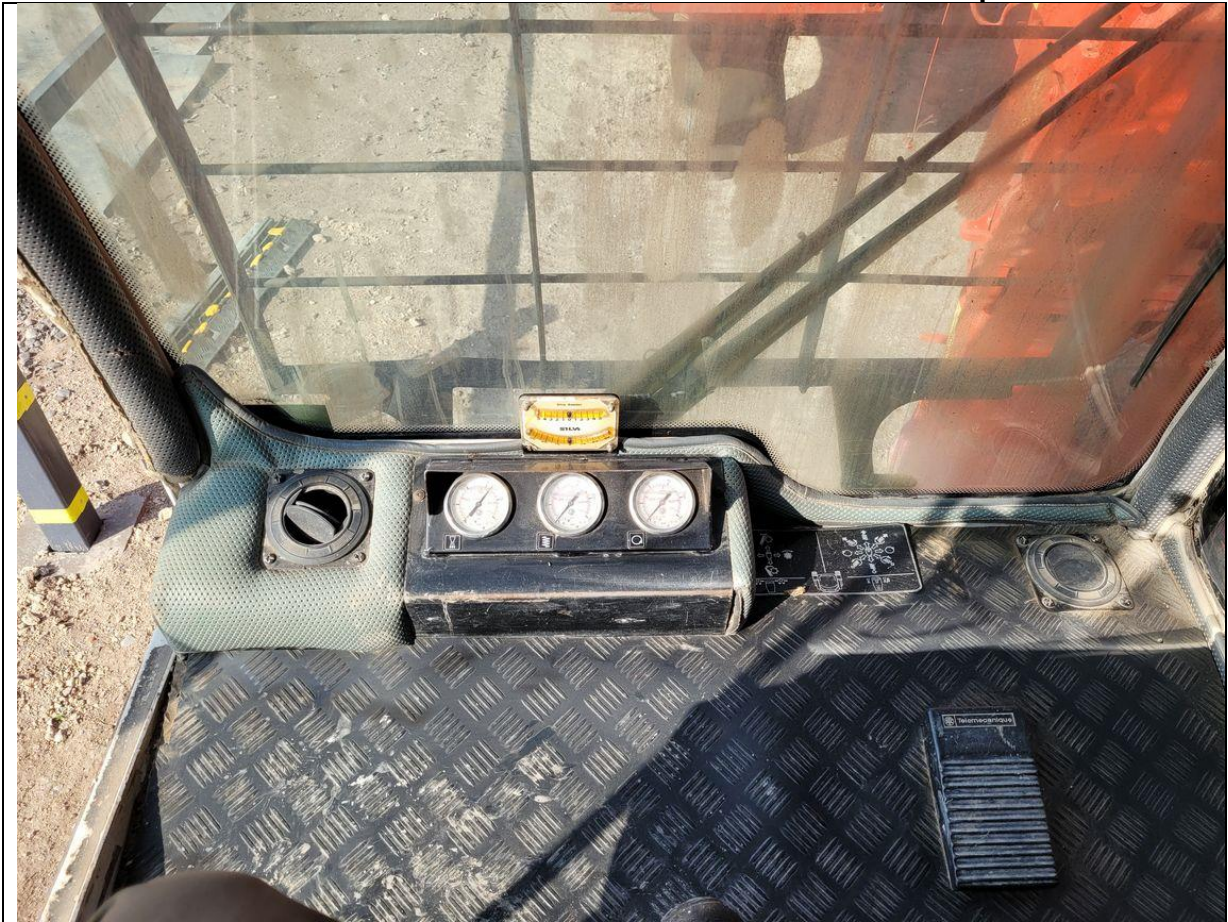
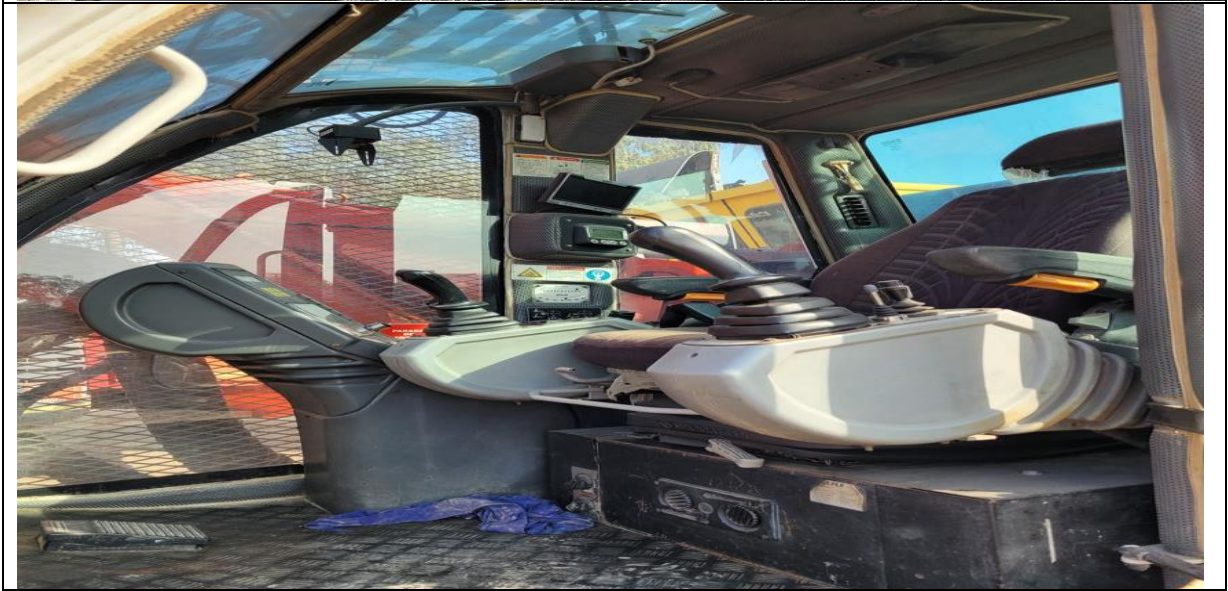
Cabin in good condition

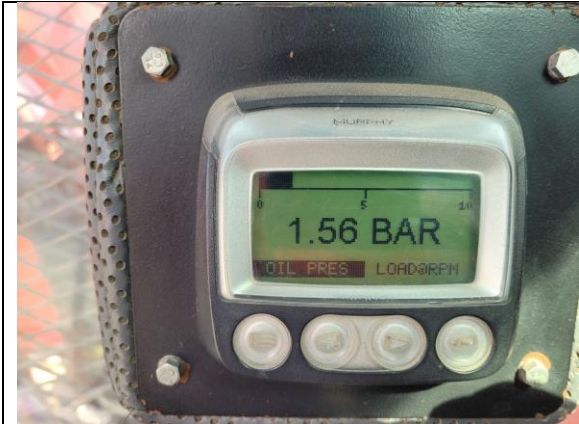
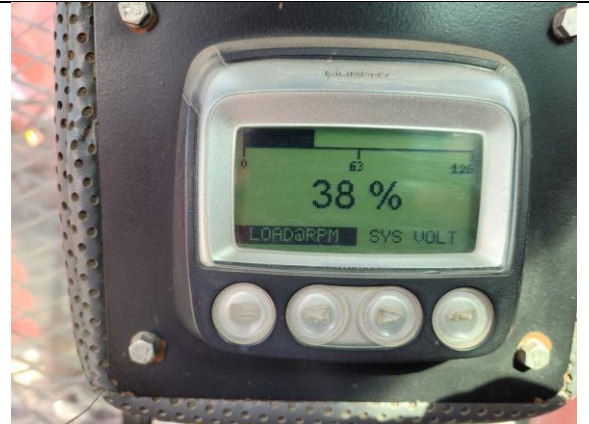
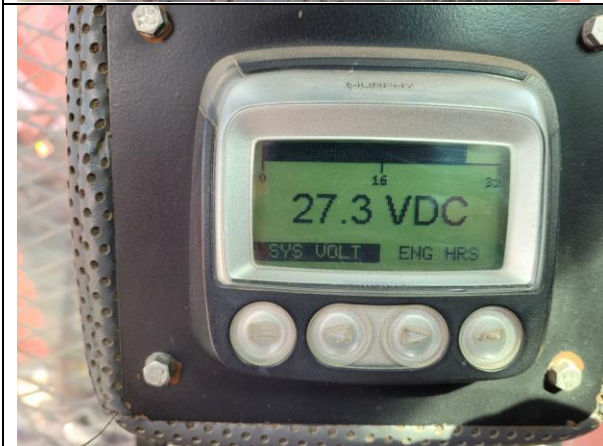
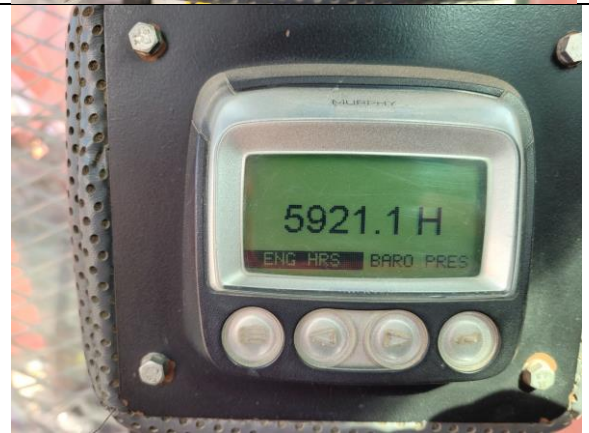
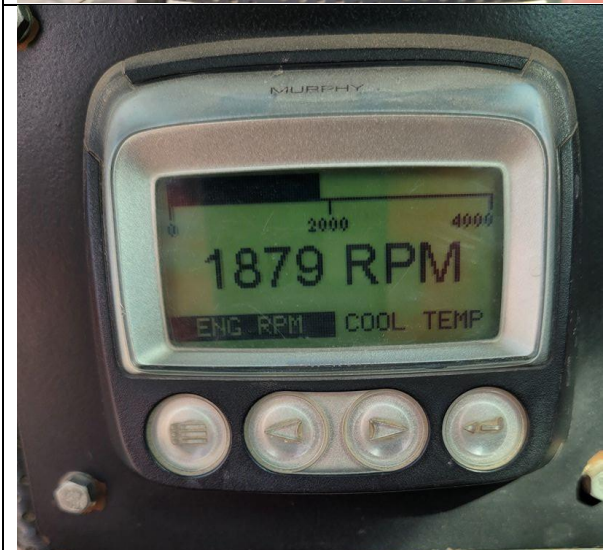
Engine parameters working normally

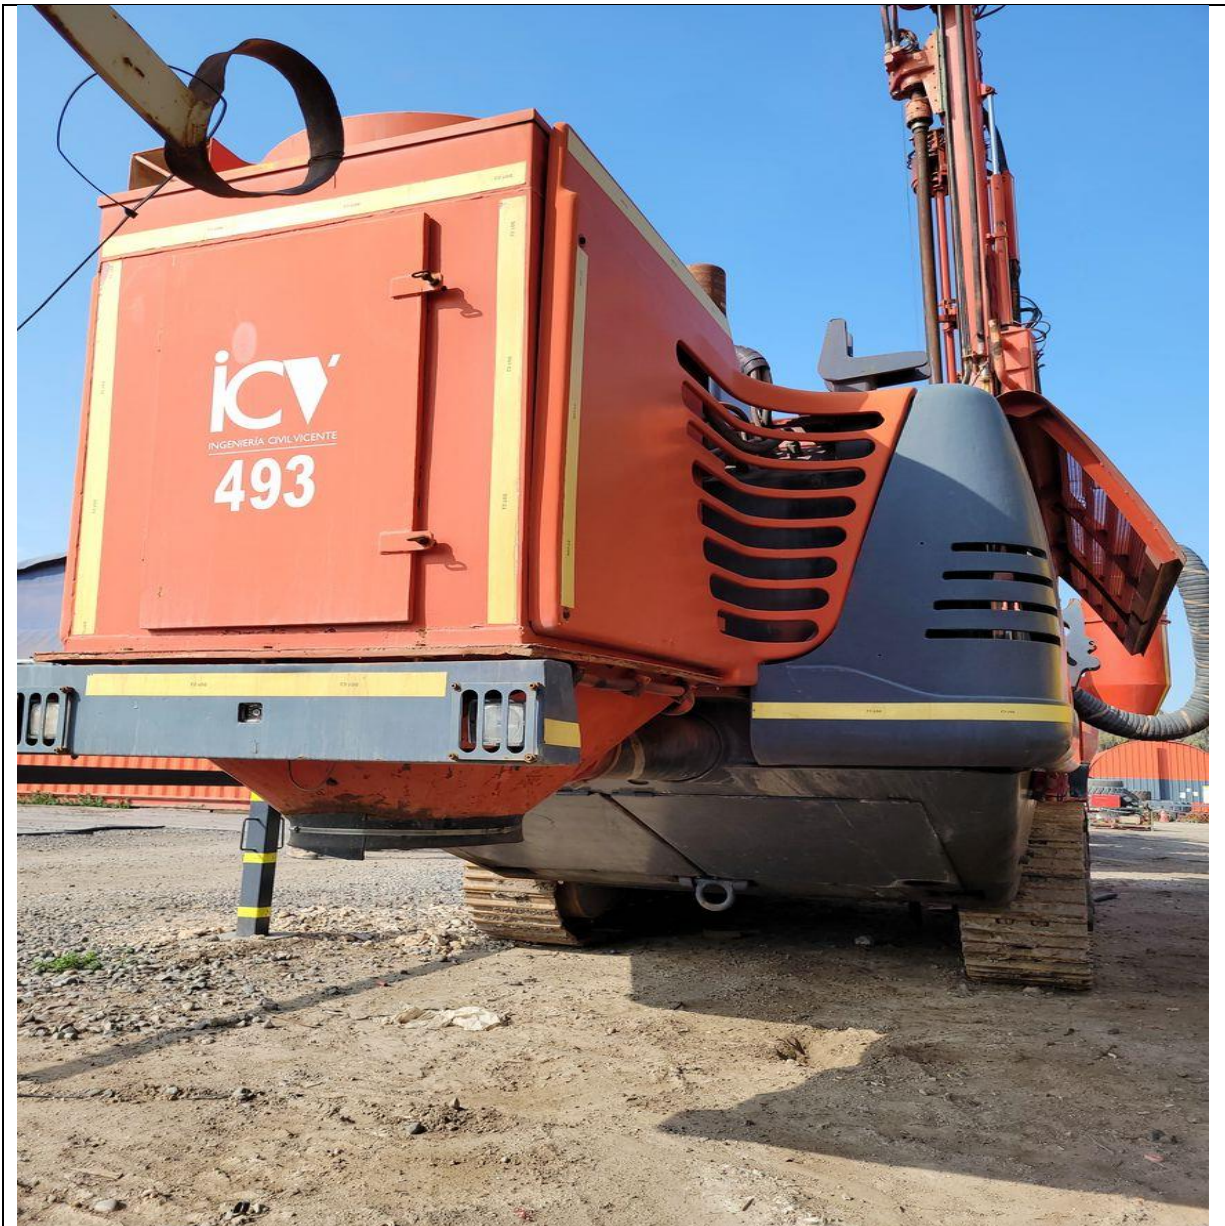
The equipment does not show damage due to impact, structure in general in good condition
